Mines Safety Bulletin No. 93

Subject: Lowering and raising of bottom guards on dozers — fatal accidents

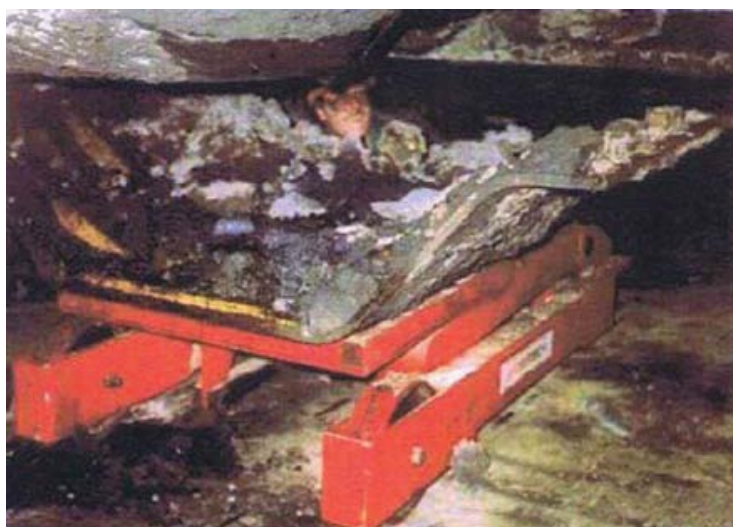
Figure 1 Example of a fit-for-purpose component handler positioned to support the bottom guard (photo courtesy of Direct Mining & Industrial International Pty Ltd)

- Information on bottom guard lowering and raising provided and updated by the OEM should be readily available for review by employees.
- Bottom guard lowering and raising work should be undertaken in a workshop environment with the aid of fit-for-purpose lifting and lowering equipment to control the movement of the guard (see example in Figure 1).
